Fan Coil Demo Installation Report

The building address and unit numbers are replaced by Building X, Y and unit#00 for the confidentiality of our client's information. The project took place in a 2 building condominium complex built in 1978 located in Greater Toronto Area.

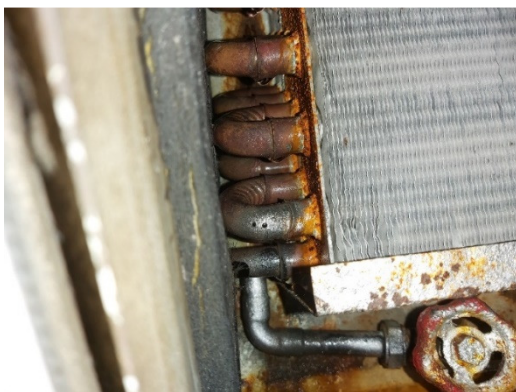
Figure 2 Coil Copper Tube Corrosion

After identifying these key problems, we proposed to install 3 new 'Unilux' fancoil insert units replacing the selected old fan coils. The problems exist throughout the building and all the fancoils and associated piping have reached the end of their service life spans. With the 3 trial installations, we aimed to fine tune the installation process, identifying any possible problems that may arise.

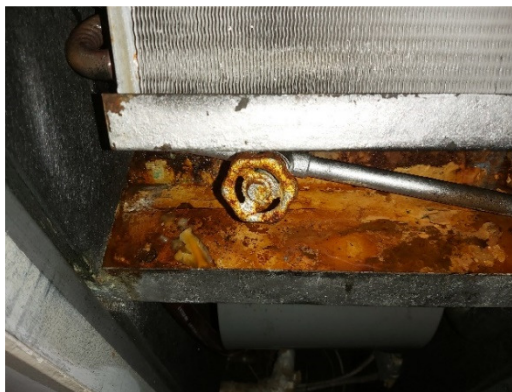
Figure 1 Rusty drip tray and bacterial growth

- The stainless steel drain pan is significantly more resistant to corrosion and bacteria growth than the original pans.
- Overflow float switch: In case clogging happens in the drain stack, each drain pan has a condensate sensor that senses the accumulating water and will shut down the fan-coil to prevent the risk of flooding.

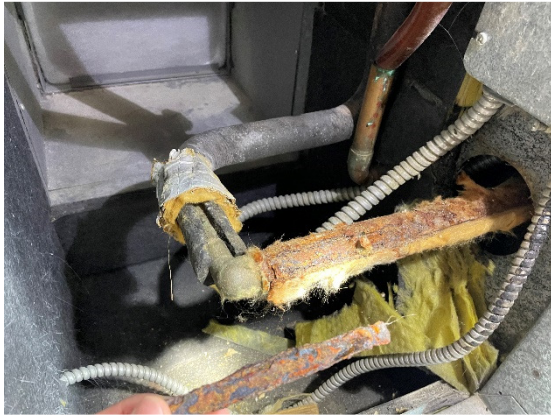
Figure 3 Corroded run-out pipes

Run-out pipes were replaced with new copper piping and shut-off valves. This will address the high flood risk in the building and will provide water flow to the fan-coil units that were lacking due to clogged runout pipes.

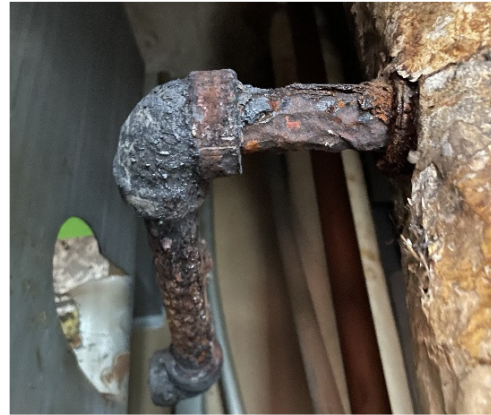
Figure 4 Runout piping

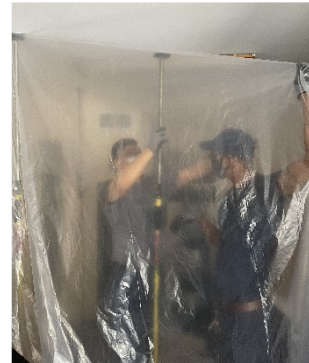
The installation started with setting up a “tent” covering the fan-coil unit and the working area, to avoid the spread of fibreglass and/or construction debris during the dismantling of the unit. Contractors will protect flooring and carpets inside the suites with proper covering sheets to avoid dirt and damage.

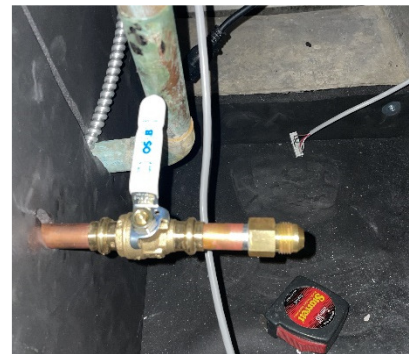
Plumbers accessed the unit’s existing supply and return runout pipes and remove them from the riser. Then, they proceeded to install the new runout pipe with shut-off valves.

Figure 5 New runout with isolation valve

This process required access to the risers located next to the fan-coil units behind the wall. In some cases, plumbers might be able to perform the work within the fan-coil casing, without breaking any drywall. In these 3 installations, however plumbers had to cut a section of the drywall due to the unique situation of each unit.

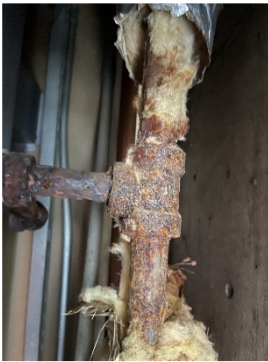
Figure 7 Old riser take off

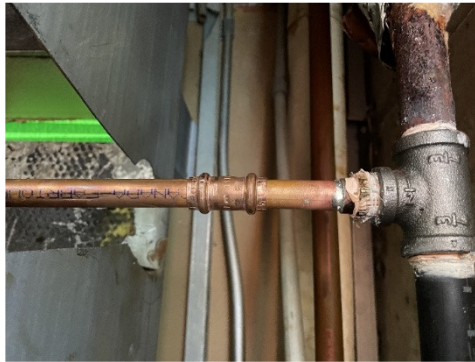
Figure 6 new riser take off

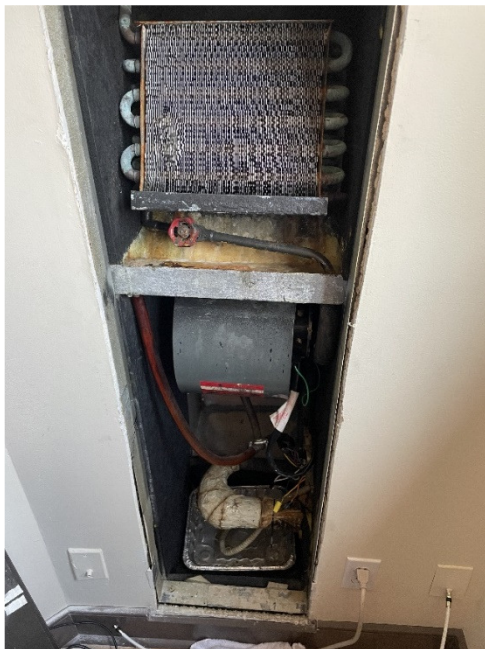
Figure 8 Fan-coil Unit Before

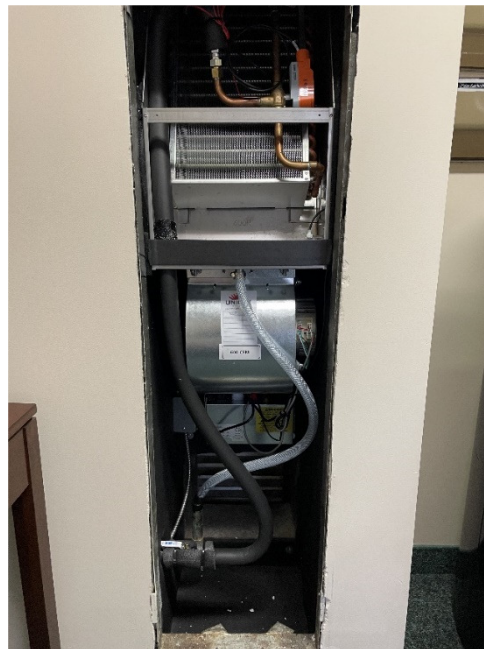
Figure 9 Fan-coil unit After

New fan coil inserts fit seamlessly into the existing cabinets. Some of the major advantages of the new fan-coil units to existing units are listed below:

We measured the sound levels for the new fan-coil units and observed a significant noise reduction. The board room fan-coil unit measured 39dbA, 49.5dbA and 51.3dbA at low medium and high settings respectively. This value is on average 5dbA lower than the previously measured noise level. The new fan-coil unit thermostat allows a high-speed setting to be bypassed on the auto setting for residents who desires even quieter operation for bedroom units.

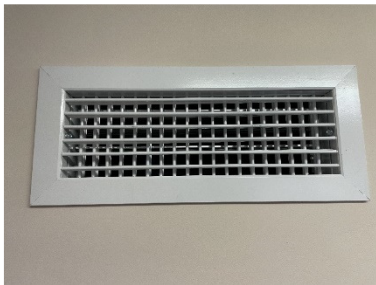
Figure 10 new fancoil supply grille

There are some options available from Unilux for future installations. New supply grilles and fan coil cover grilles are available if the board decides to replace them. We left a sample cover and installed a new grille in the meeting room at *Building X*.

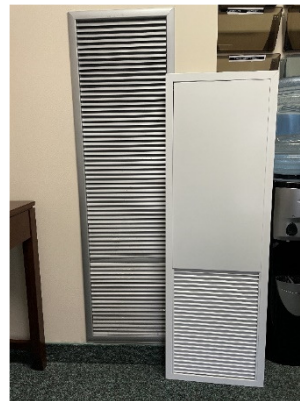
Figure 11 New fancoil cover
